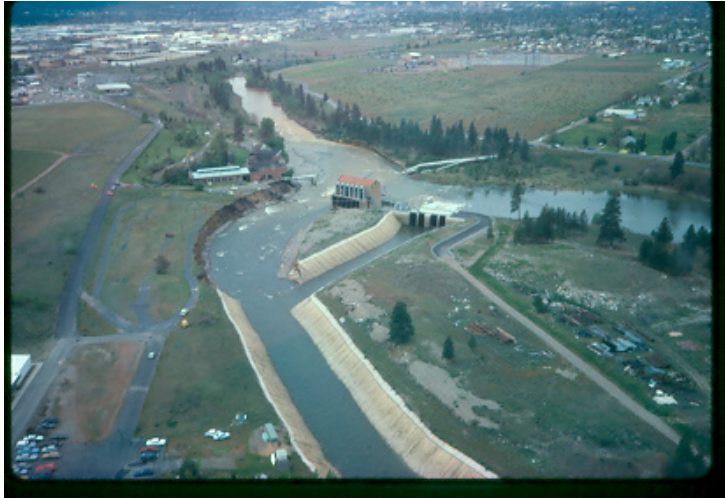
Photo 1. Aerial View of Powerhouse Intake Channel and Powerhouse

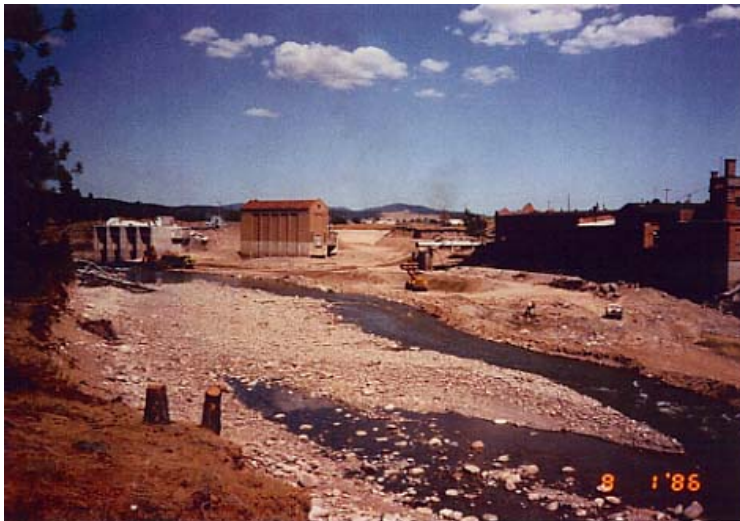
Photo 2. Powerhouse and Bank Erosion from Downstream

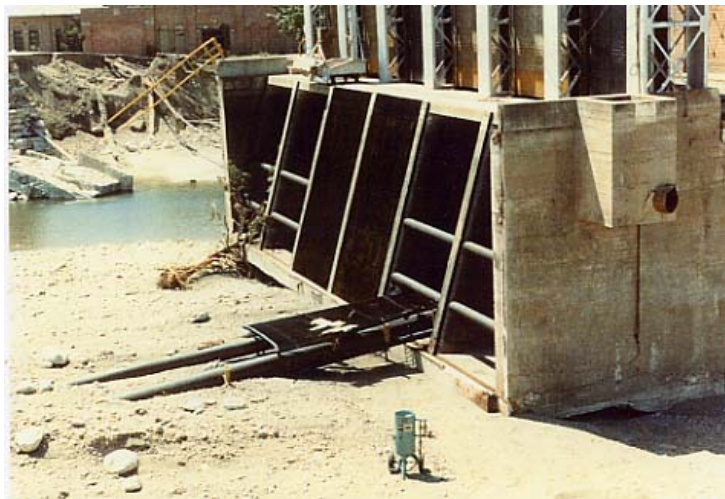
Photo 3. Channel Erosion adjacent to Powerhouse Intake

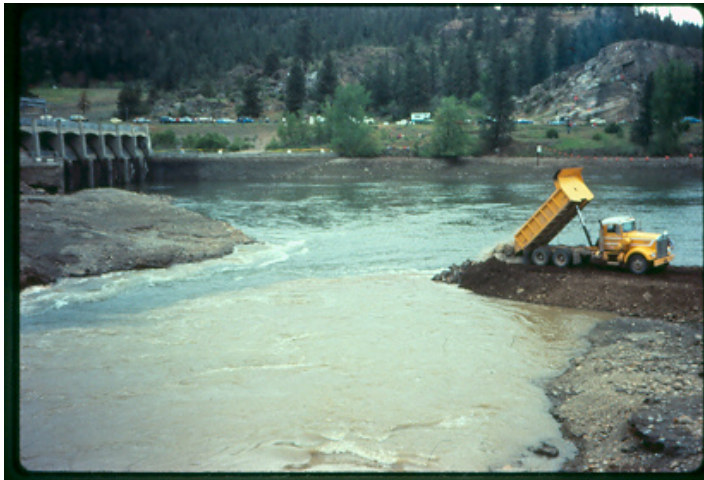
Photo 4. Repairs at Mouth of Powerhouse Intake Channel

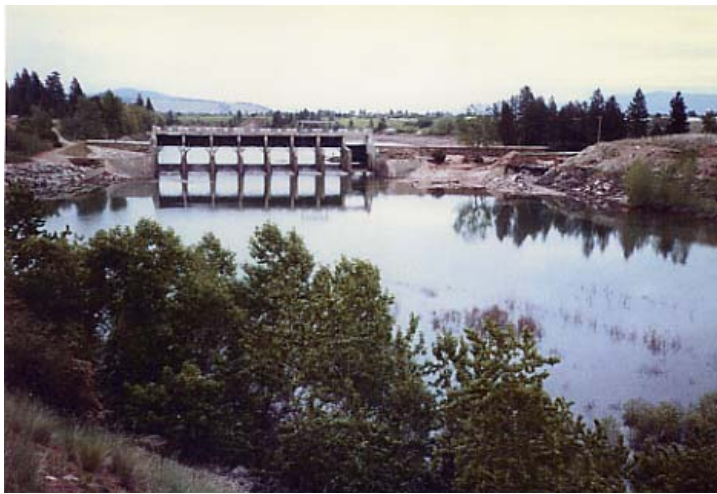
Photo 5. Erosion at Upriver Dam from Downstream

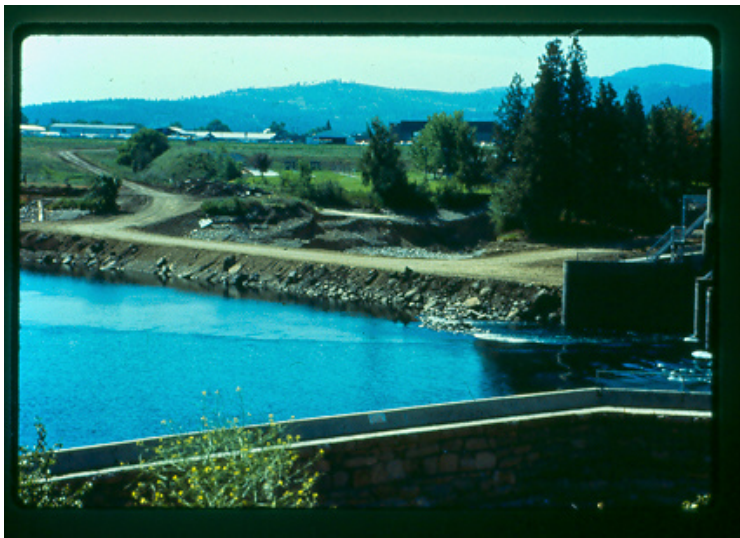
Photo 6. Repairs South of Dam Face from Upstream
